MISCELLANEOUS PAPER CERC-86-8

STABILITY TEST OF MODIFIED REPAIR OPTIONS FOR SAN PEDRO BREAKWATER LOS ANGELES, CALIFORNIA

Coastal Model Investigation

R. Clay Baumgartner, Robert D. Carver,
D. Donald Davidson, Charles R. Herrington

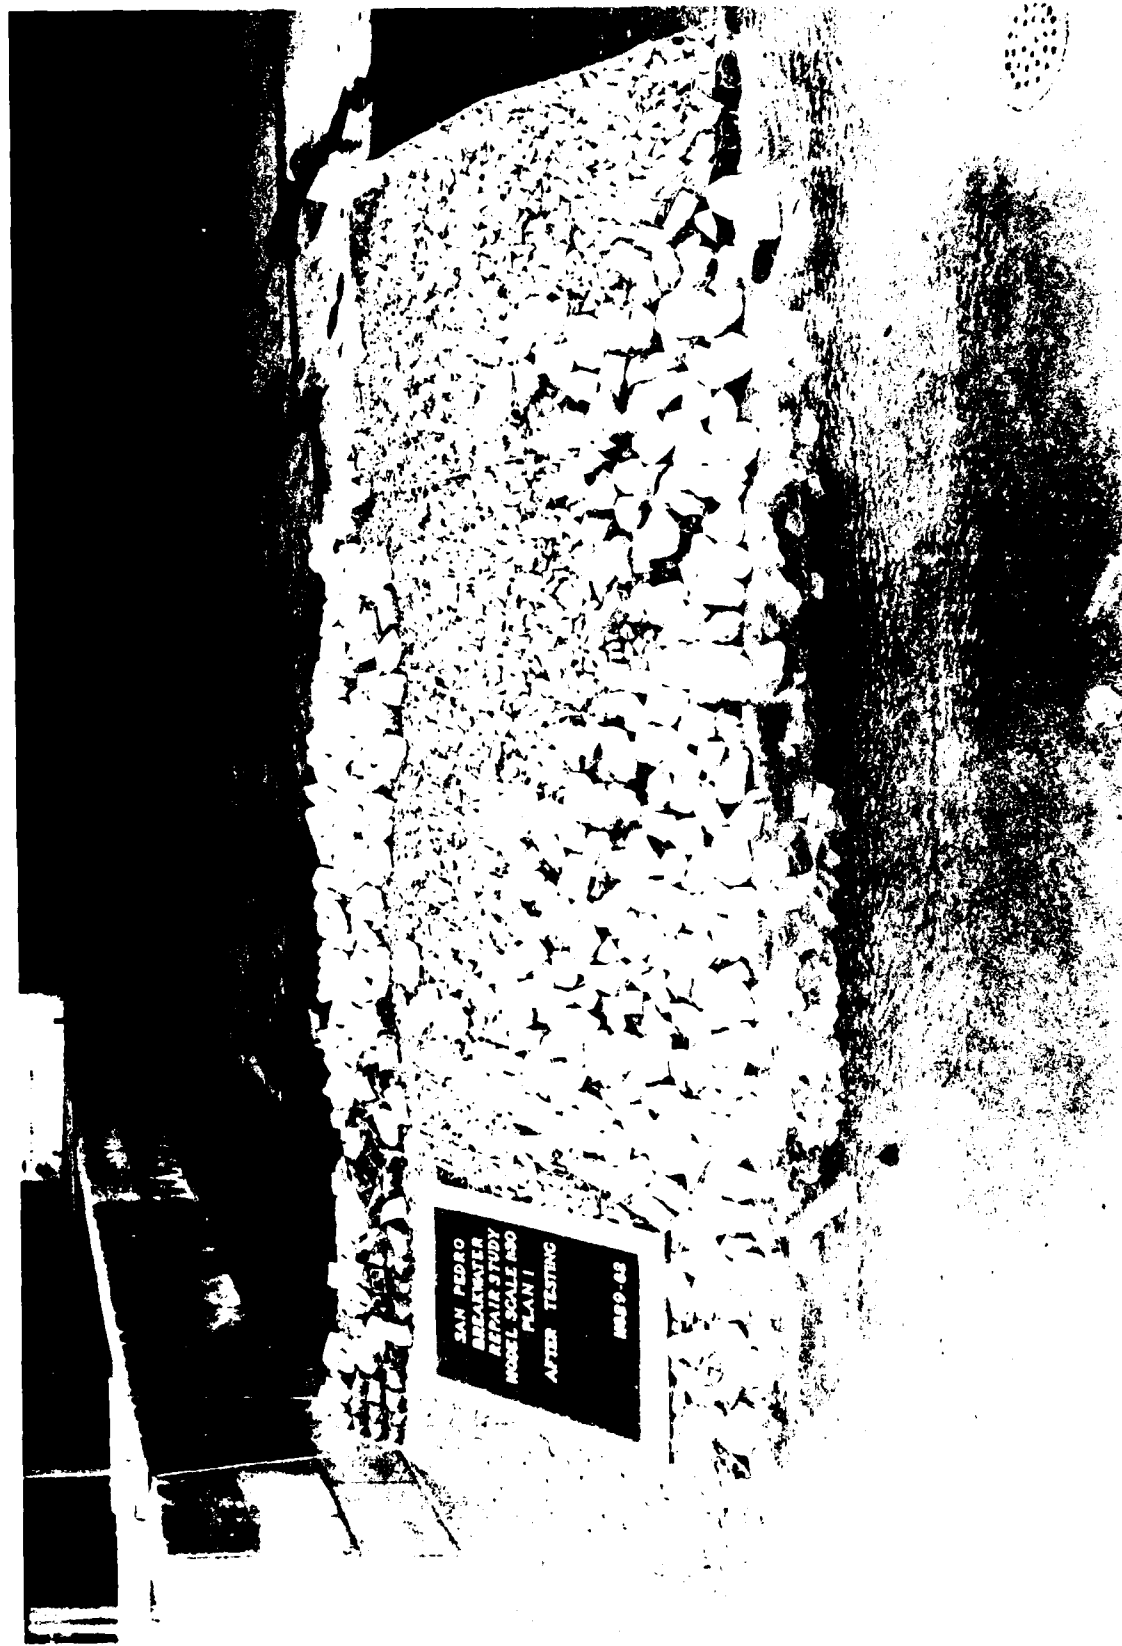
14. Plan 1 (Photos 1-4 and Plates 1-4) was constructed to model the 1983 repair of the breakwater. The rubble mound repair (Plate 4) consisted of three to four layers of 7- to 20-ton angular stone placed randomly, with one-half of the repair section including the bottom layer of the sea side existing stone and some cores' one. The sea-side toe of the rubble-mound section was placed a distance of one angular stone out from the existing granite stone, i.e., approximately 25 ft horizontally from the center line of the breakwater. The harbor-side toe of the repair section was placed 18 ft out from the center line of the breakwater, the same distance out as the toe of the existing stone. At the transitions (Plate 3), existing granite-stone sections were overlaid with one layer of 7- to 20-ton angular stone for a distance of four to five stones. The test section was subjected to Hydrograph B (Table 1). Wave attack at the 0-ft mllw caused minor damage to the rubble-mound section with most of the displacement occurring during attack of the 8-sec, 16-ft waves (Step 5) and originating at the toe of the section. Wave attack at this swl produced no damage to the existing granite-stone sections. Testing at the +6 ft mllw caused severe damage to the rubble-mound section with major damage being initiated at Step 6 (6-sec, 14-ft waves) and continuing for Step 7 (8-sec, 16-ft waves). Damage originated at the transition areas of the rubble-mound section and then spread throughout the

region. Most of the displacement occurred on the sea side of the structure, but some stone shifted on the harbor side as voids were created because of stone lost on the sea side and from wave overtopping. Damage to the existing granite stone was initiated during attack of 8-sec, 16-ft waves and damage to this section was moderate after completion of testing at the +6 ft swl. Movement of the existing granite stone was severe during wave attack at the +8 ft swl. This area of the structure failed completely during testing at this water depth. Displacement of the angular stone continued during testing at the +8 ft swl, but the rate of damage was less than that for the existing granite stone and there was some angular stone remaining after completion of testing at this swl. Testing was stopped at Step 9 (8-sec, 16-ft waves) of Hydrograph B because it was deemed unnecessary to continue after the complete failure of the existing granite block sections. Representatives of the US Army Engineer District, Los Angeles (SPL), observed testing of the final portion of Plan 1 and decided that a repeat test of this plan was not necessary.

Photo 3. Sea-side view of Plan 1 after testing with Hydrograph B.
Angle of wave attack = 90 deg

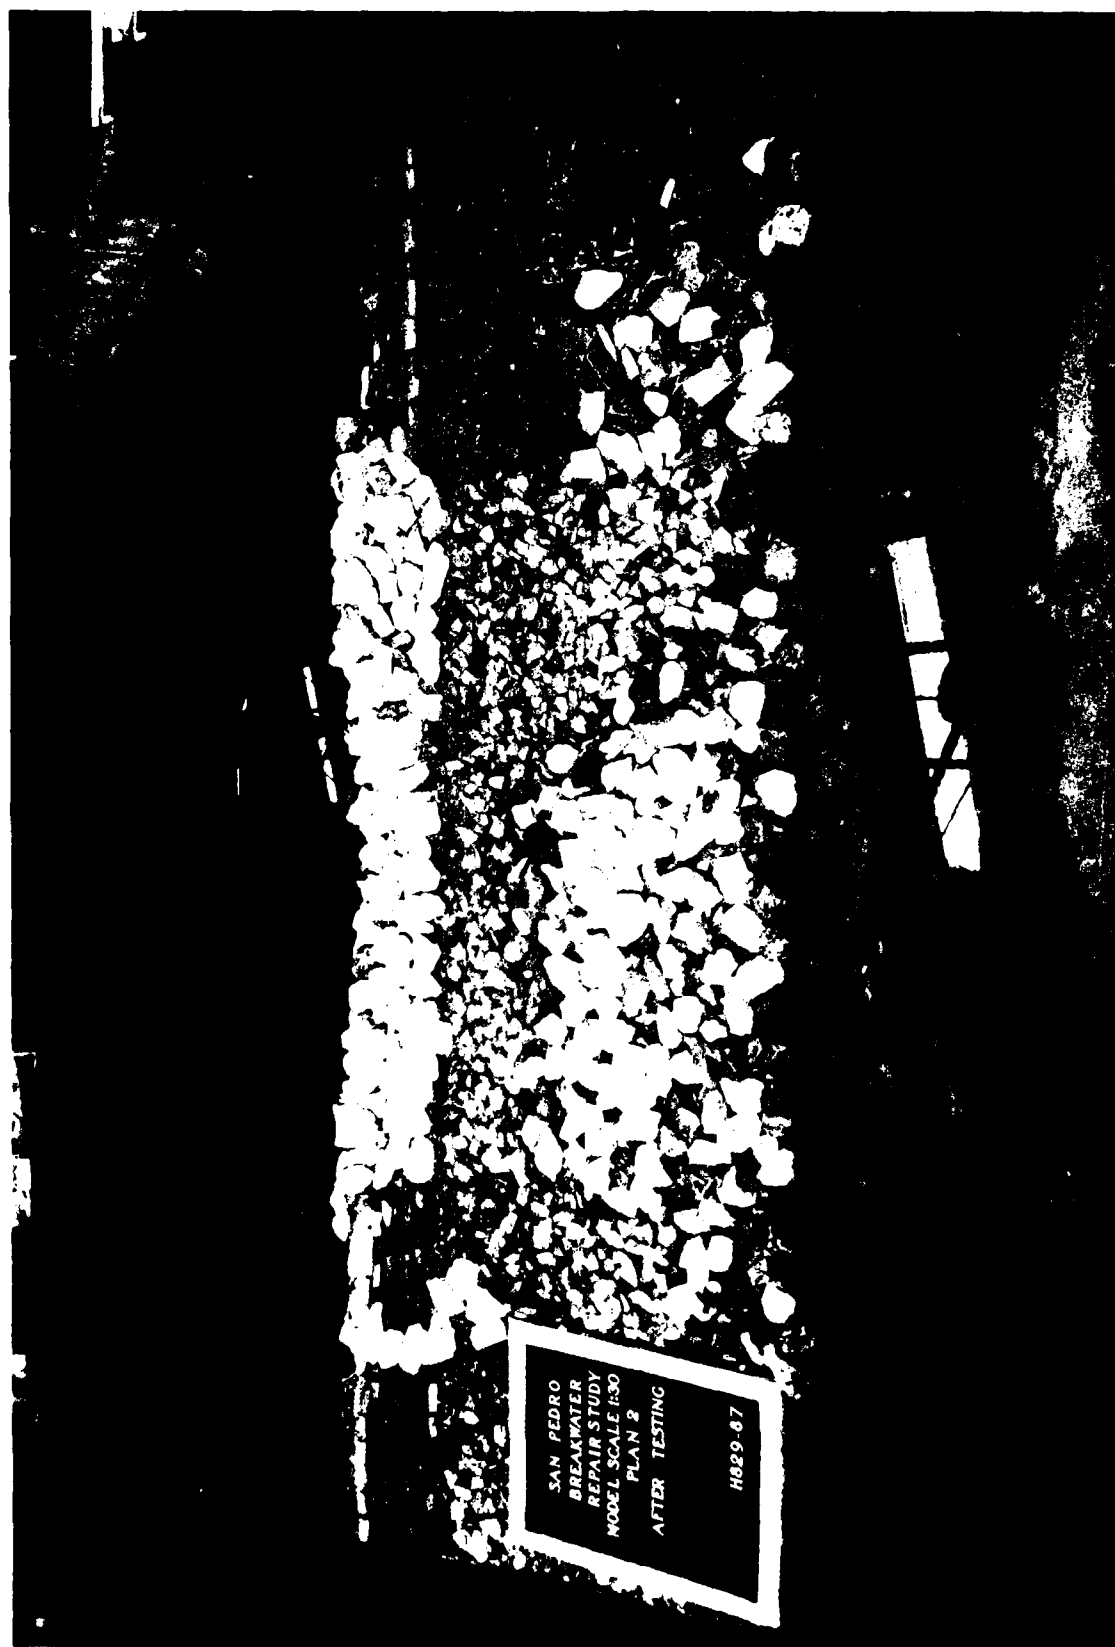
15. Plan 2 (Photos 5-8 and Plate 5) was constructed in the same manner as Plan 1 except 13- to 20-ton stone was added to the sea side of the repair section. This stone was painted blue in the model so it could be differentiated from the stone used to represent the 1983 repair section (7- to 20-ton stone). The stone appears black in the photographs. The toe of the additional stone was placed 25 ft seaward from the toe of the 1983 repair. This distance is approximately 50 ft when measured horizontally from the center line of the breakwater. The 13- to 20-ton stone transitioned into the 7- to 20-ton stone while maintaining a maximum crest elevation of +13 ft mllw. It was hoped that flattening the slope and moving the toe into deeper water would increase the stability of the section. Stone placed along the toe on the 1V on 3H slope of the base mound appeared to be very vulnerable to wave attack. In fact, it was difficult to place the toe stone during construction as it tended to roll downslope. The test section was subjected to Hydrograph A (Table 1). Damage to the new stone section was initiated during Step 1 (6-sec, 8-ft waves, 0-ft mllw) and originated at the toe. Continued wave attack at the 0-ft mllw caused severe damage to the added stone in the rubble-mound section; however, the additional stone protected the stone representing the 1983 repair. Testing at the +8 ft swl caused extensive damage to the stone from the 1983 repair with damage initiating at Step 6 (6-sec, 14-ft

waves) and progressing with continued wave attack. Damage to the existing granite stone was also initiated during attack of 6-sec, 14-ft waves at the +8 ft swl. Wave attack during Step 8 (11-sec, 16-ft waves) caused significant damage to the granite stone, and extensive damage was done during Step 10 (22-sec, 16-ft waves) with this section failing completely. The additional stone added some reserve stability to the rubble-mound section and there was more stone left after testing than for Plan 1. Testing was stopped after Step 10 of Hydrograph A, because it was determined unnecessary to continue after complete failure of the existing granite block sections had taken place.

Photo 8. Harbor-side view of Plan 2 after subsection to Hydrograph A.
Angle of wave attack = 90 deg

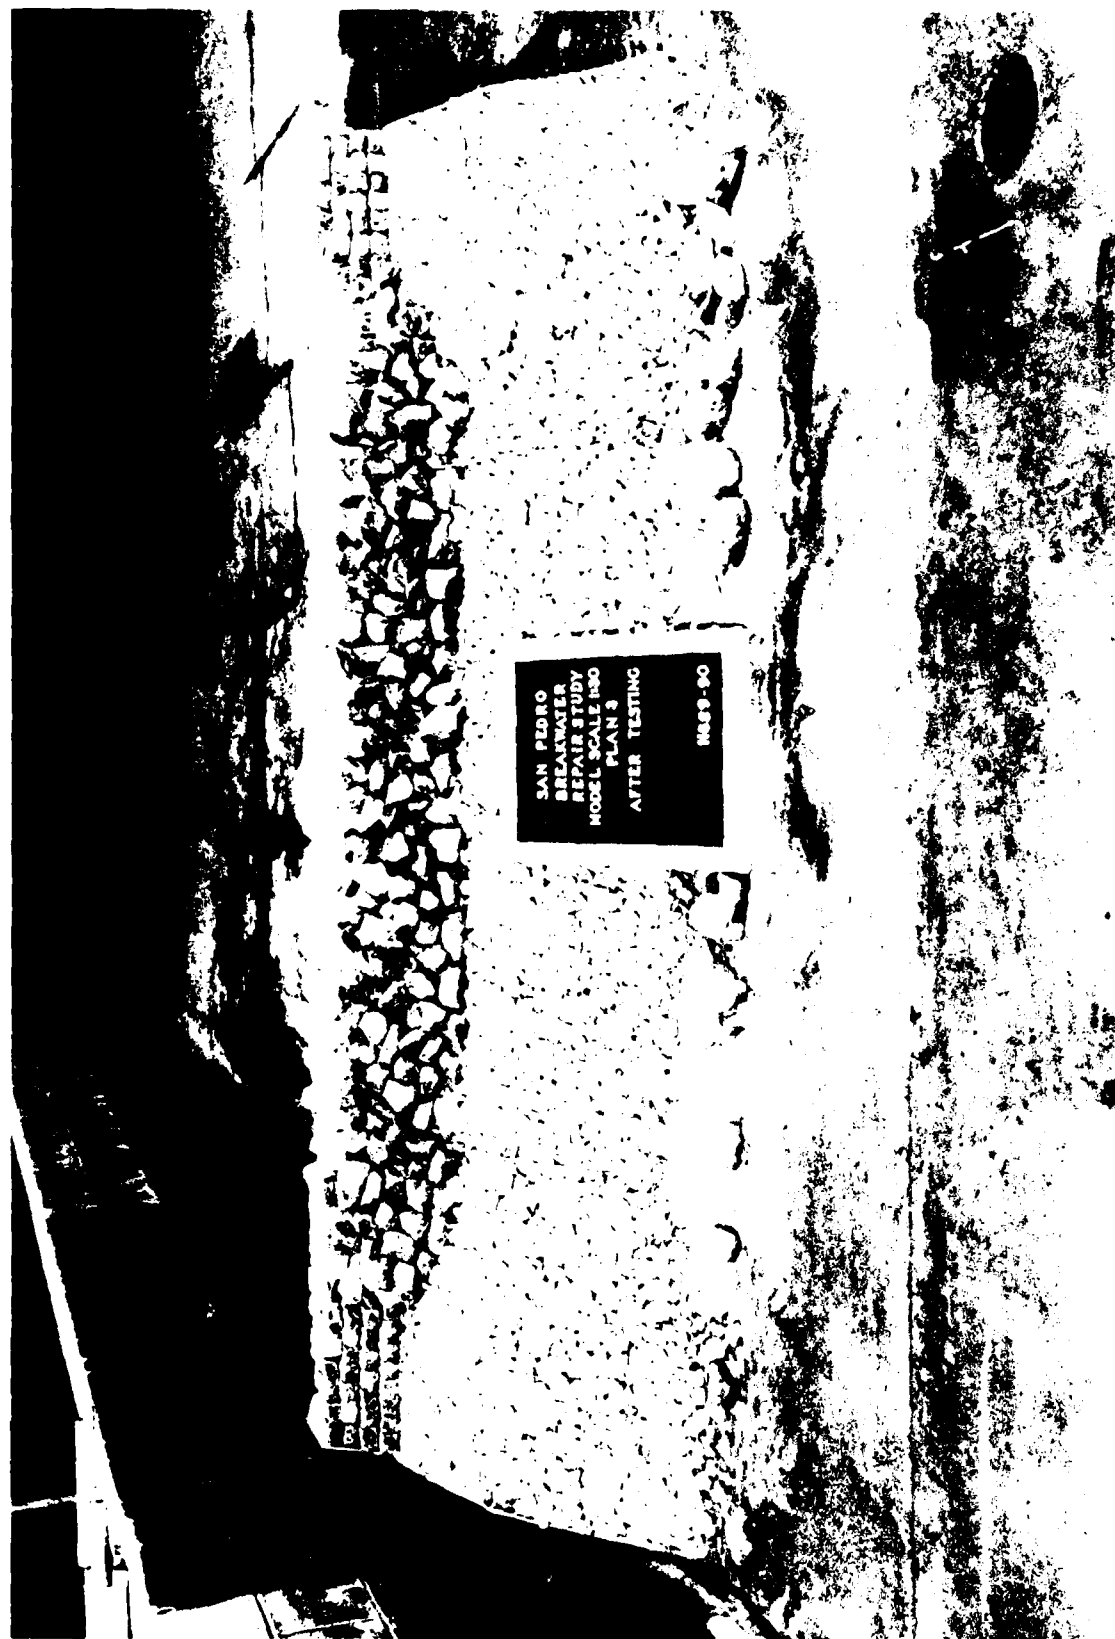
16. Plan 3 (Photos 9-14 and Plate 6) was similar to Plan 2 except a trench was excavated along the toe of the added 13- to 20-ton stone. The trench was about 7 ft wide and 3.5 ft deep, i.e., wide enough to allow a 20-ton stone to be placed inside at a depth of approximately one-half that of the stone. After the 13- to 20-ton stones were placed in the trench, voids between the stones were backfilled with material left from the excavation. A total of 478 7- to 20-ton stones and 246 13- to 20-ton stones were placed in the model. The test section was subjected to Hydrograph A. Wave attack at the 0-ft swl caused minor damage to the rubble-mound section with the first stones being displaced during attack of the 6-sec, 12-ft waves (Step 2). Most of the movement occurred in the transition areas. Wave attack at this swl caused no damage to the existing granite stone sections, and only one stone was displaced from the area representing the 1983 repair. During wave attack at the +8 ft swl, several additional stones were randomly displaced throughout the rubble-mound section, but the total damage to this area was still minor. Damage to the existing granite block stone was initiated during Step 6 (6-sec, 14-ft waves) and became extensive during Step 8 (11-sec, 16-ft waves). This area of the structure failed completely. Testing was stopped after completing Step 8 of Hydrograph A. The test section was rebuilt and subjected to Hydrograph B with similar results. Damage was initiated during Step 5 (8-sec, 16-ft waves, 0-ft mllw) for the 13- to 20-ton stone and during Step 8 (6-sec, 14-ft waves, +8 ft mllw) for the existing granite block sections. Damage to the existing granite block sections was significant during Step 9 (8-sec, 16-ft waves, +8 ft mllw) with these sections failing completely during tests at the +8 ft swl. Hydrograph B was run to completion with the rubble-mound section sustaining only minor damage except in the transition areas where stone was lost after the existing granite block sections had failed

Photo 11. Sea-side view of Plan 3 after subsection to Hydrograph A.
Angle of wave attack = 90 deg

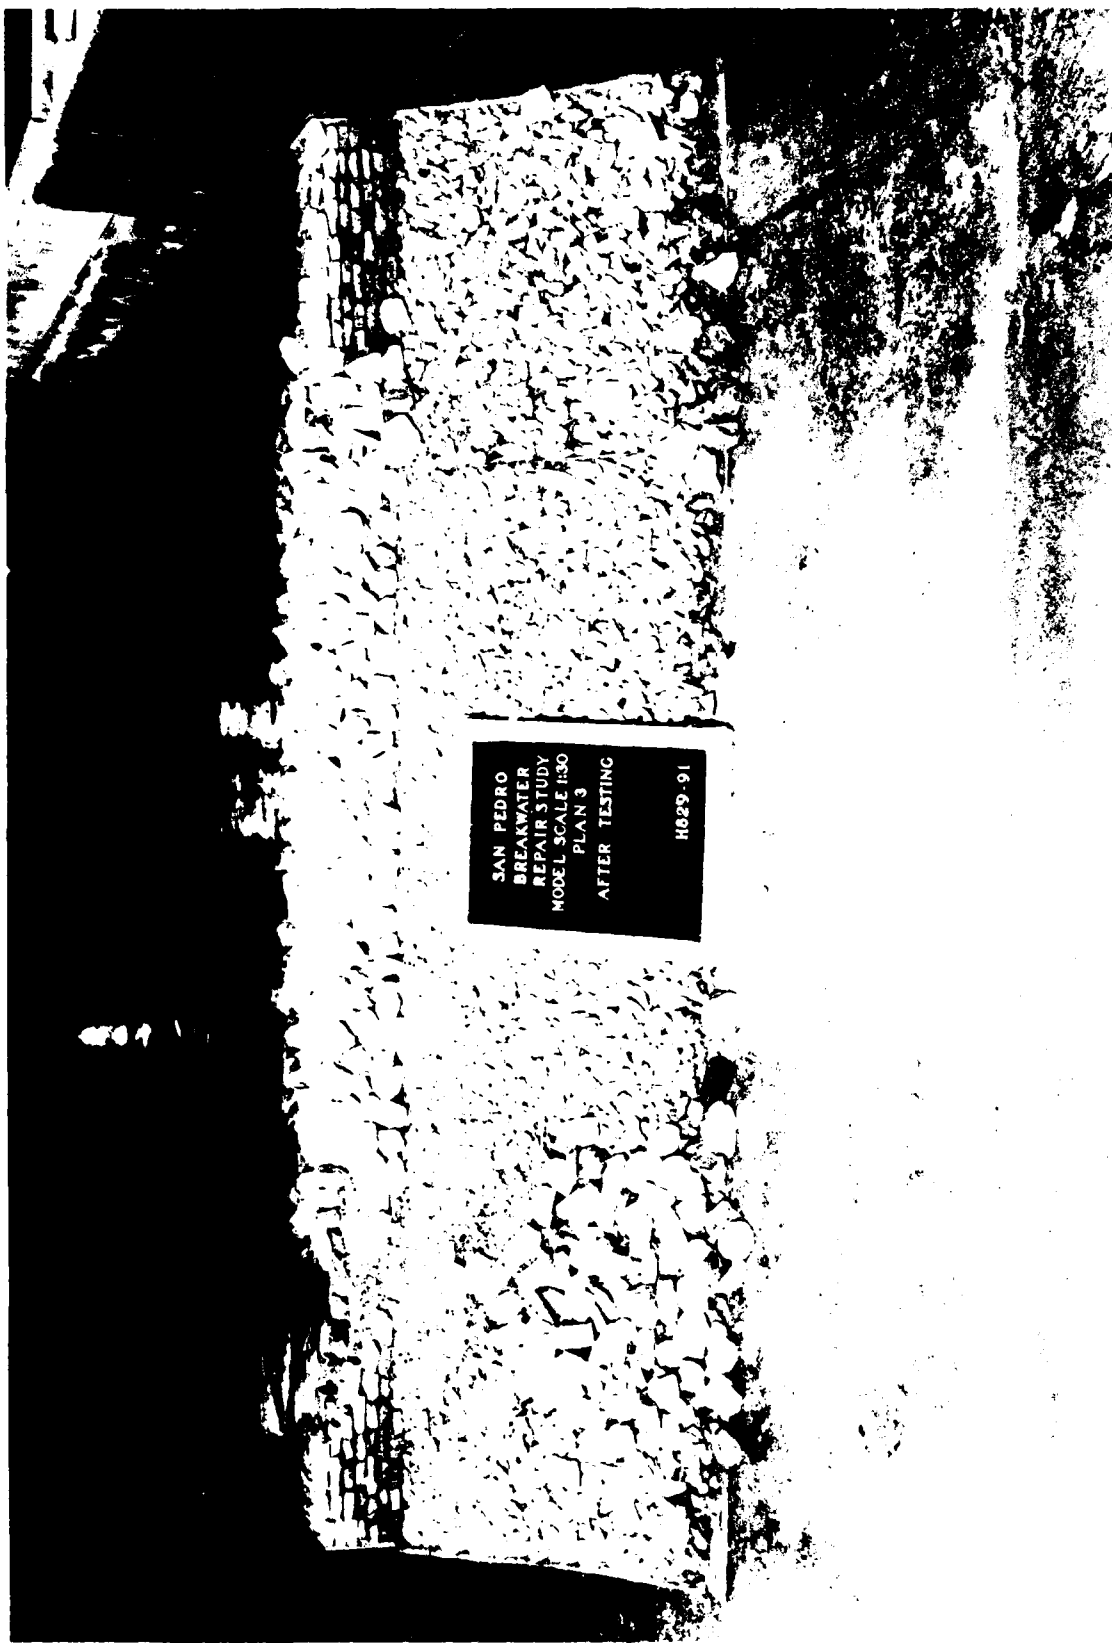
Photo 12. Harbor-side view of Plan 3 after subjecting to Hydrograph A.
Angle of wave attack = 90 deg

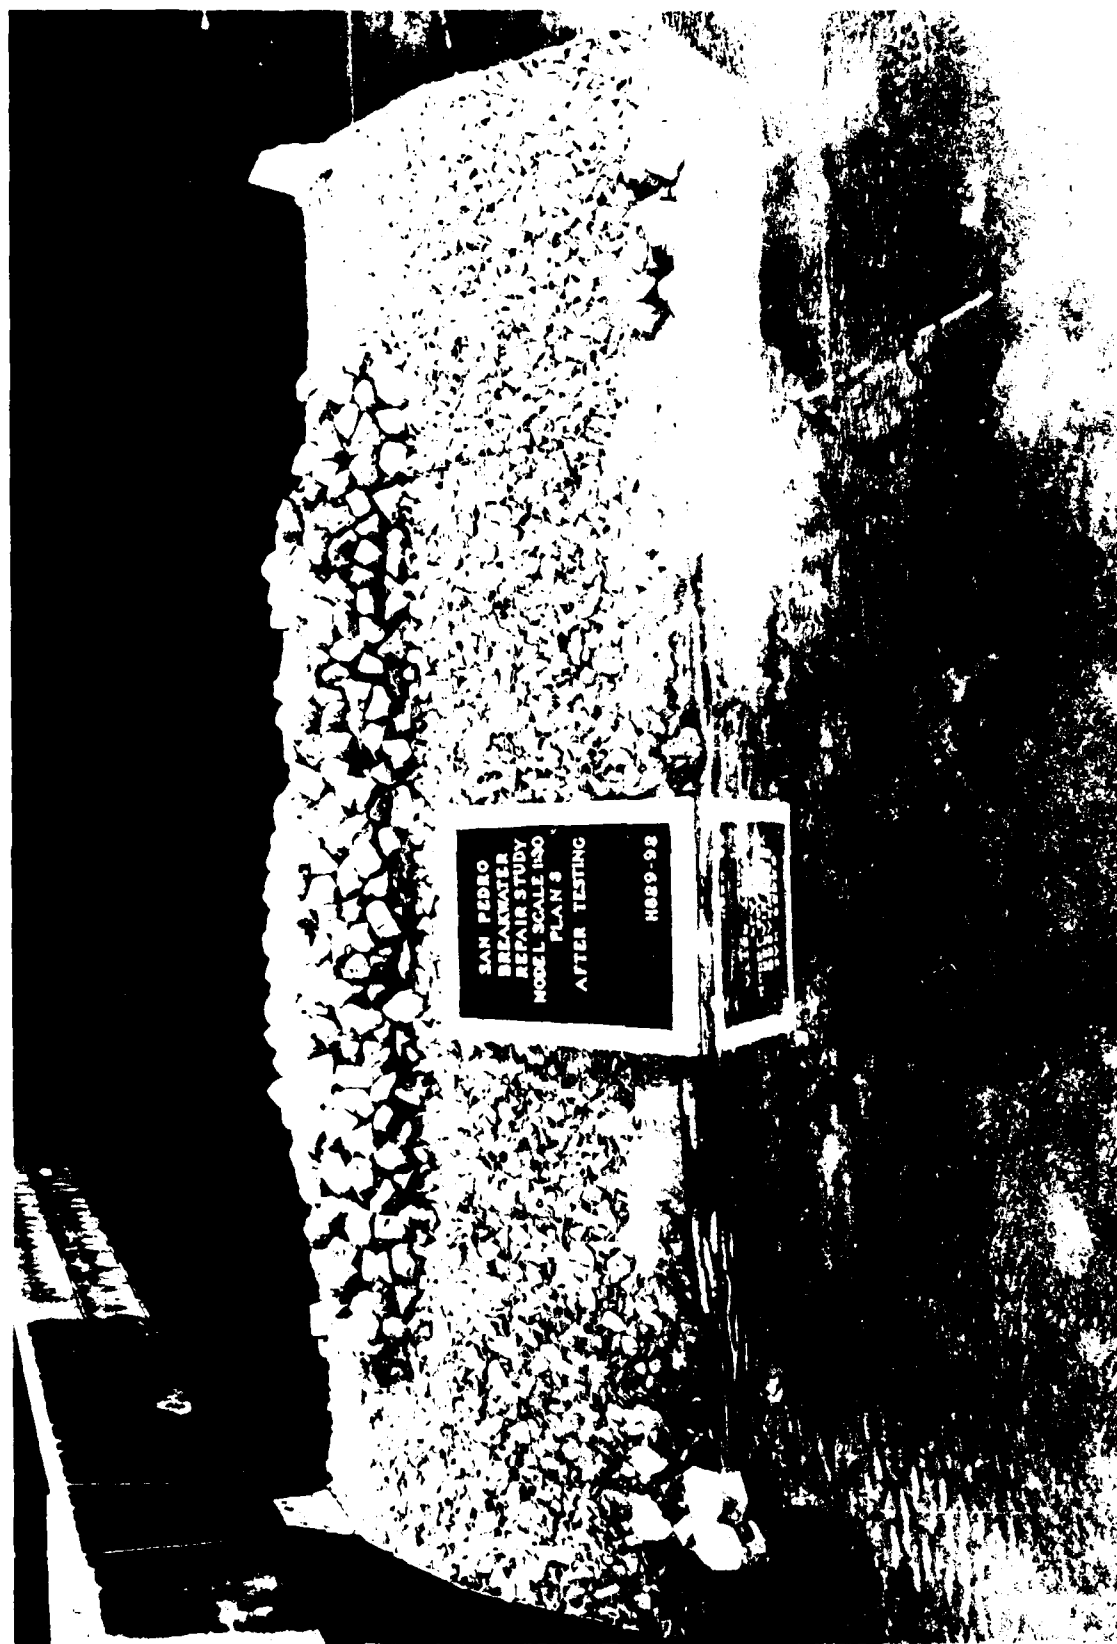
completely. Based on these test results, it can be concluded that Plan 3 offers a repair option that is more stable than the original breakwater.

Photo 13. Sea-side view of Plan 3 after subsection to Hydrograph B.
Angle of wave attack = 90 deg

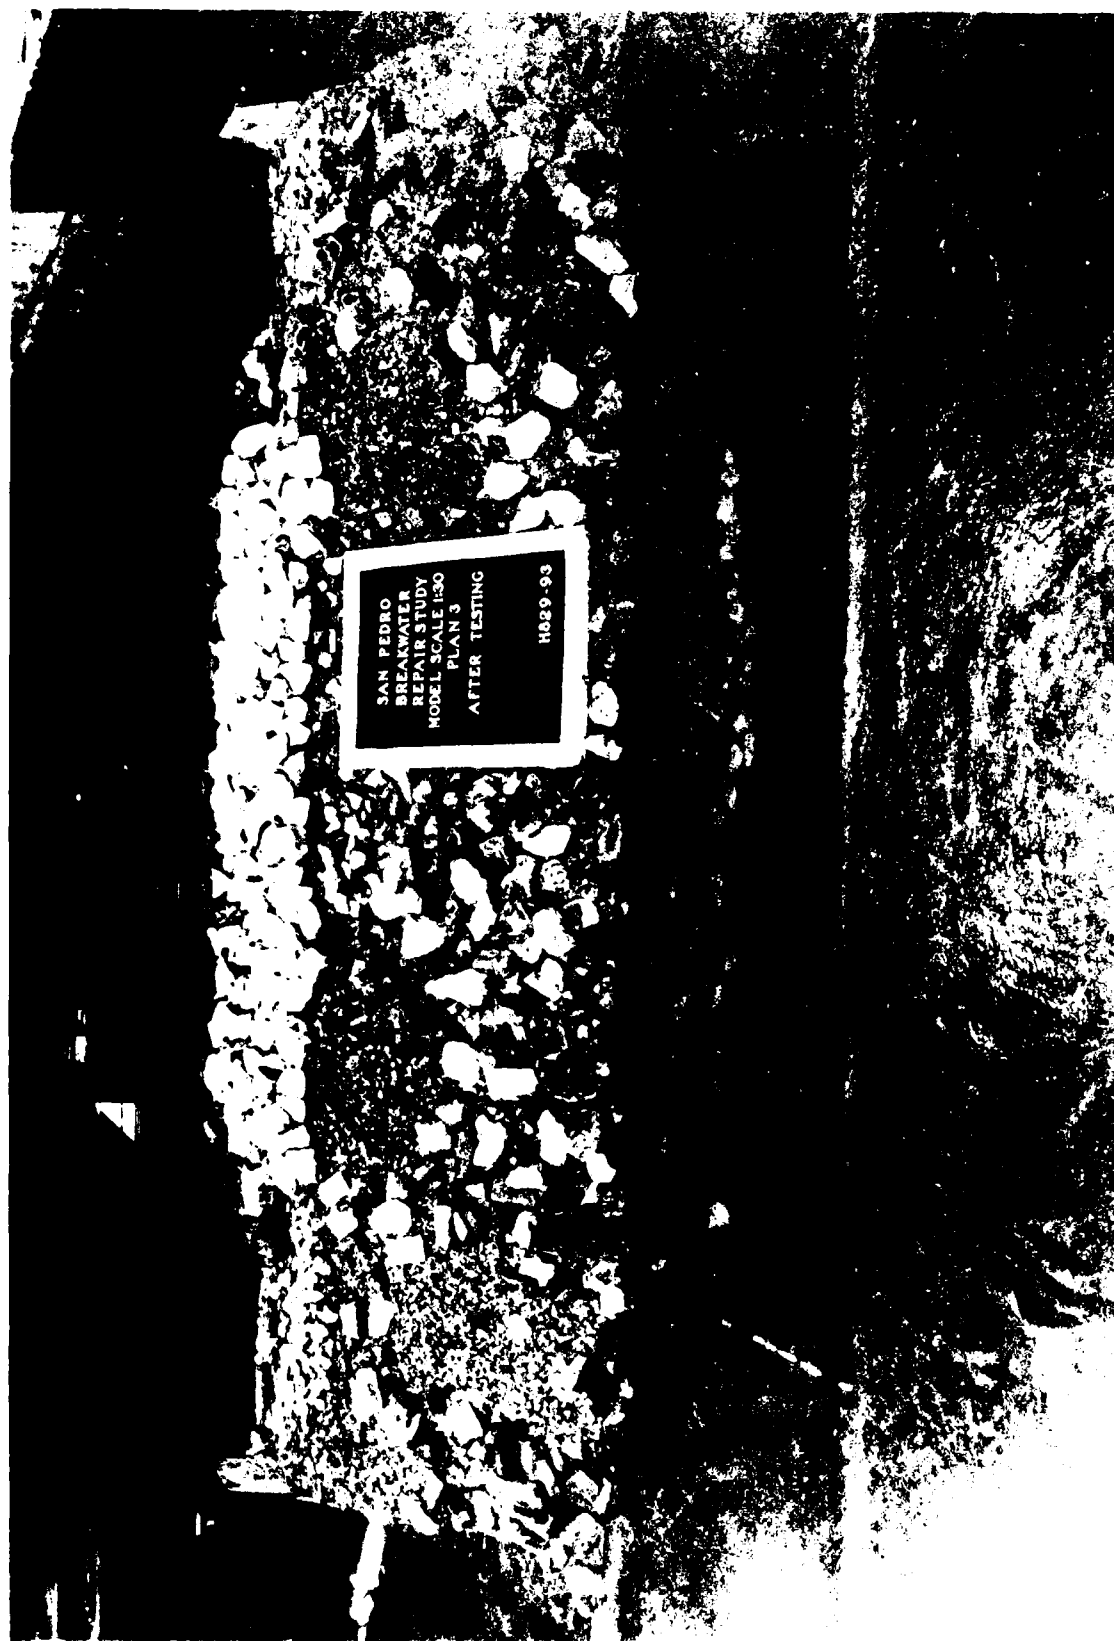
Photo 14. Harbor-side view of Plan 3 after subjecting to Hydrograph B.
Angle of wave attack = 90 deg

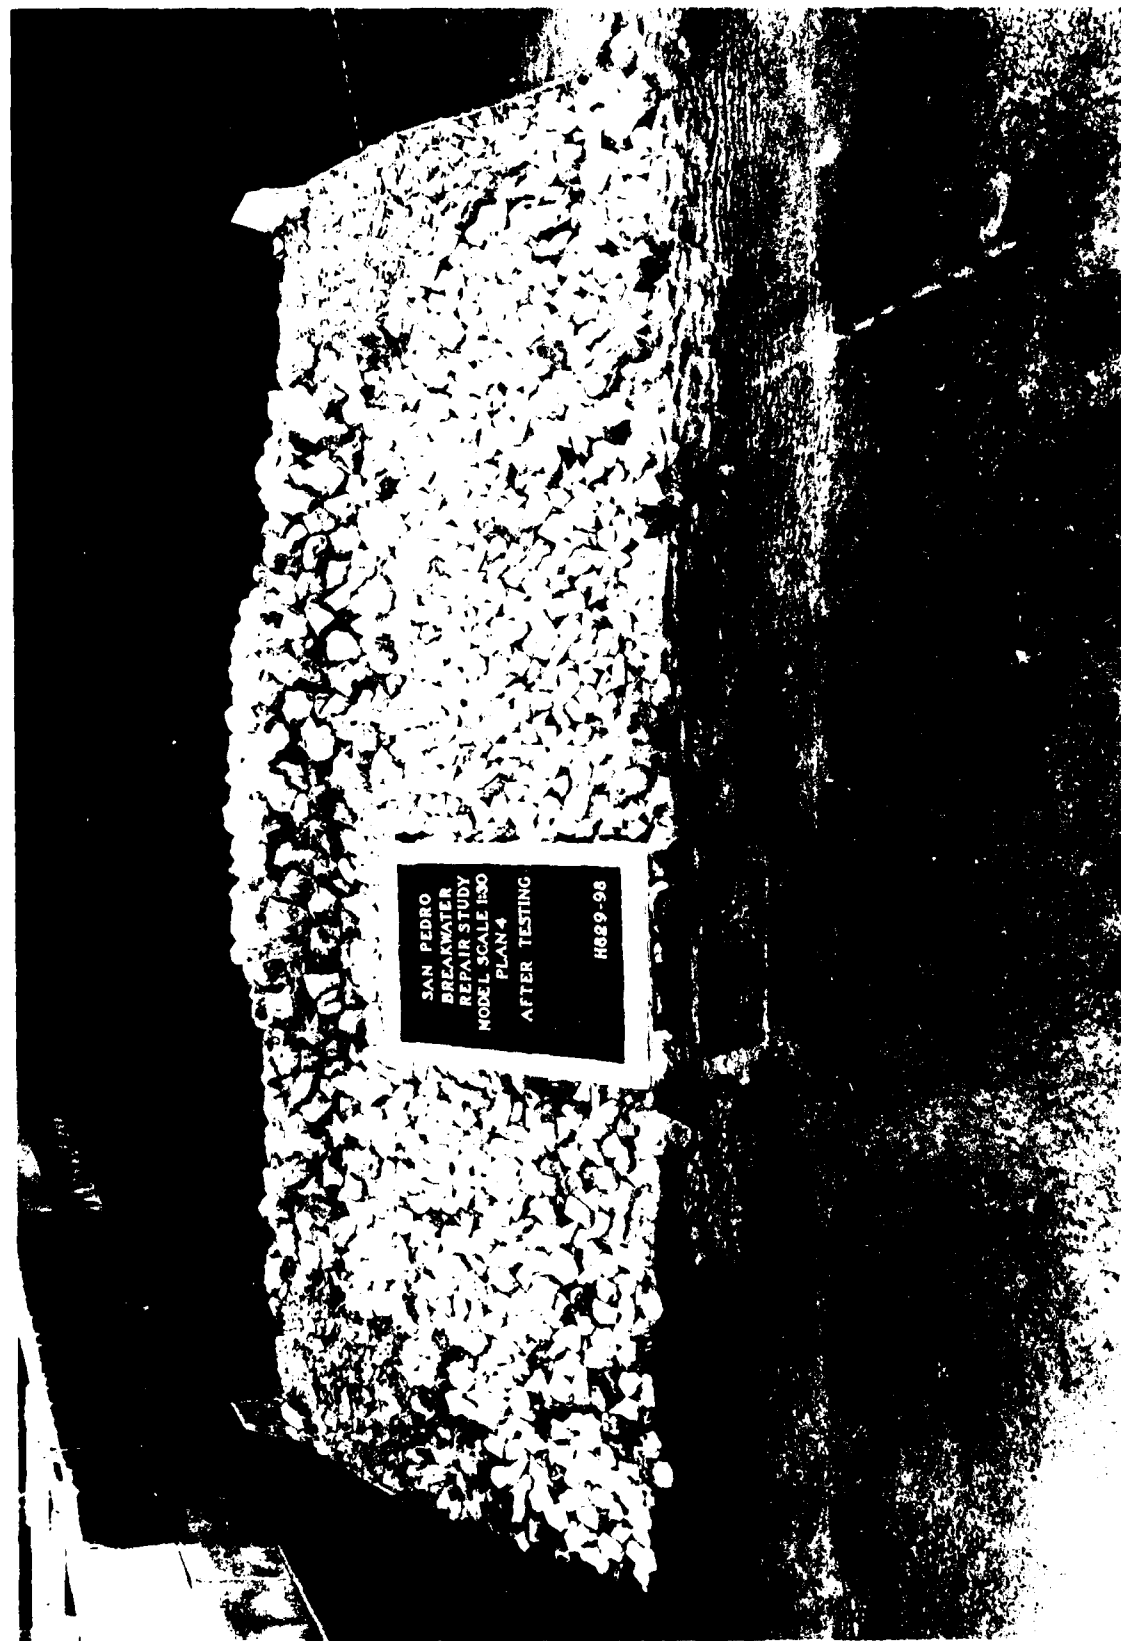
17. Plan 4 (Photos 15-18 and Plates 7-8) was the same as Plan 3 except the toe stone on the sea side of the repair section was buttressed with two layers of 3- to 4-ton angular stone rather than being placed in a trench. Placement of the 3- to 4-ton stone started at the toe of the base mound, -47 ft contour, and then continued upslope to the point where the 13- to 20-ton stone started. The 3- to 4-ton stone bordered the 13- to 20-ton stone in the transition areas (see Plate 8). A total of 475 7- to 20-ton stones, 245 13- to 20-ton stones, and 1,746 3- to 4-ton stones were placed in the model. The test section was subjected to Hydrograph B. Wave attack at the 0-ft swl caused minor damage to the 3- to 4-ton stone with most of the smaller stone in the transition areas being displaced. The 3- to 4-ton stone along the toe of the 13- to 20-ton stone remained stable. Wave attack at the 6 ft swl caused minor damage to the 13- to 20-ton stone with most damage occurring during attack of 8-sec, 16-ft waves; displacement was concentrated in the transition areas. Damage to the existing granite block sections was initiated during Step 9 (8-sec, 16-ft waves, +8 ft mllw) with these sections failing completely during Step 10 (11-sec, 16-ft waves, +8 ft mllw). Wave attack at the +8 ft swl caused minor damage to the rubble-mound section because of overtopping. Hydrograph B was run to completion with some additional damage occurring in the transition areas where stone was lost after the existing granite block sections had failed completely. Based on these test results, it can be concluded that Plan 4 offers a repair option that is more stable than the original breakwater but less stable than Plan 3.

Photo 17. Sea-side view of Plan 4 after subsection to Hydrograph B.
Angle of wave attack = 90 deg

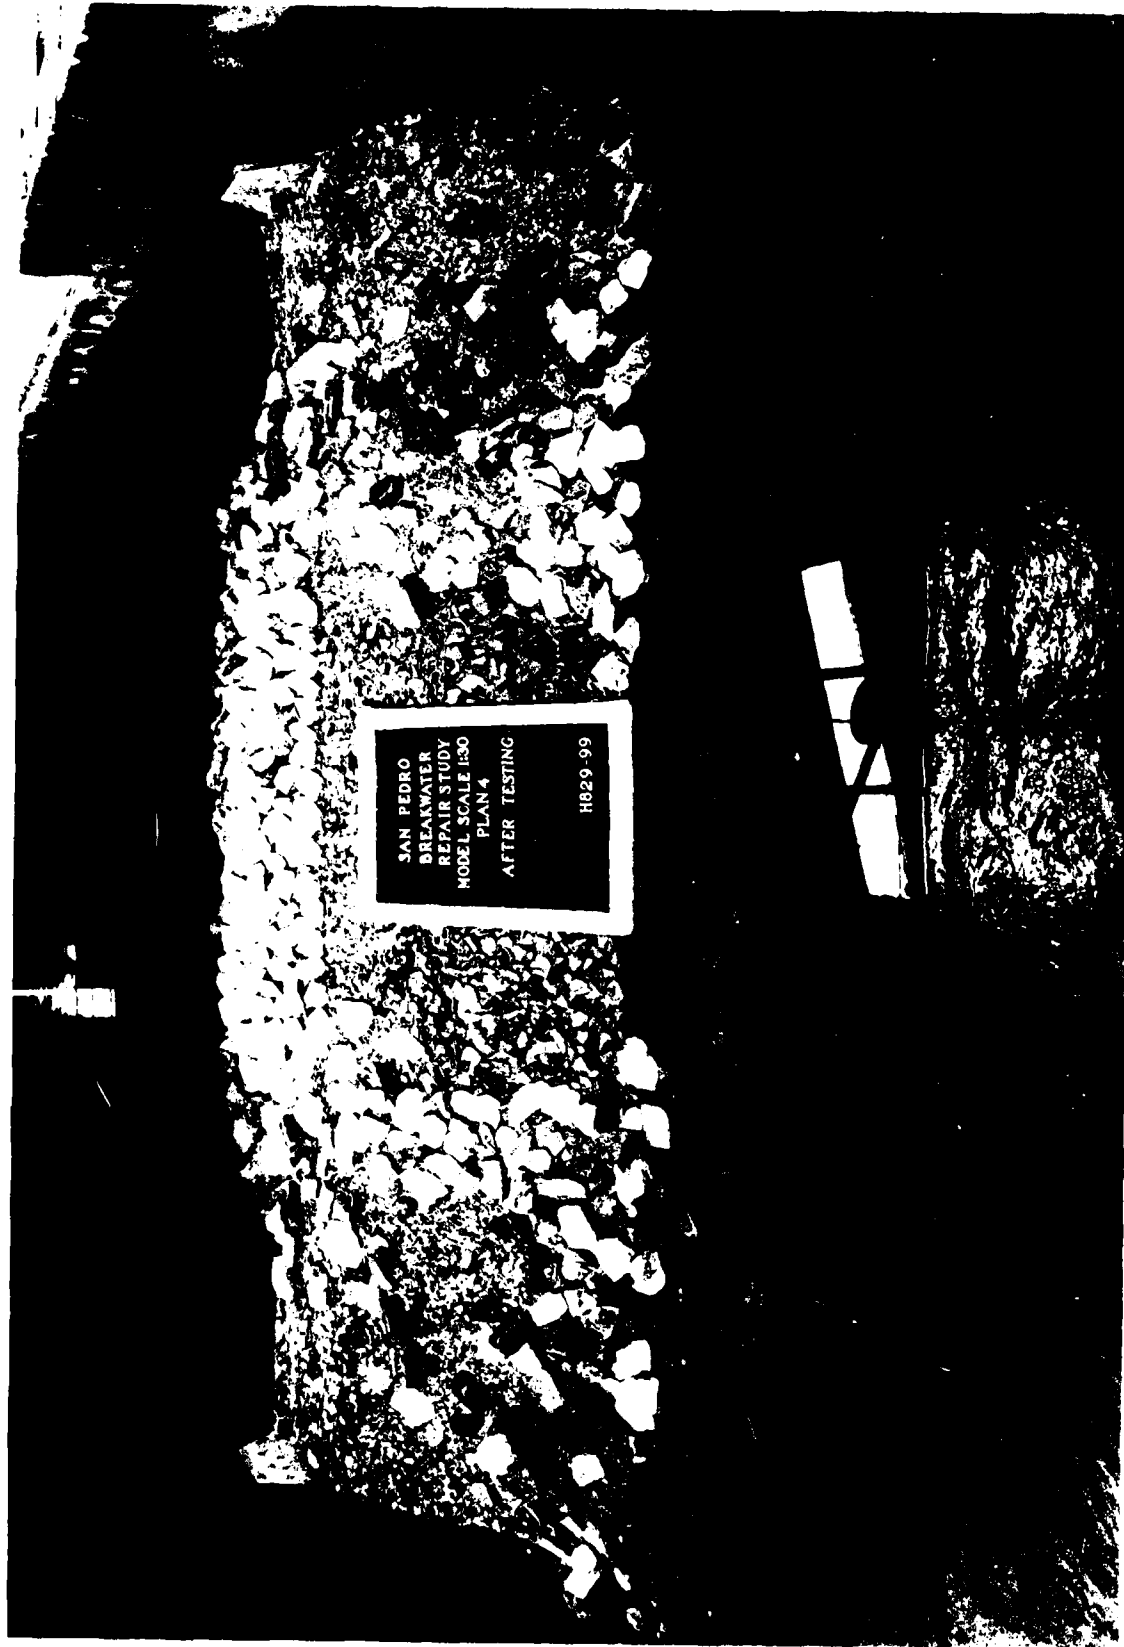
Photo 18. Harbor-side view of Plan 4 after subjecting to Hydrograph B.
Angle of wave attack = 90 deg

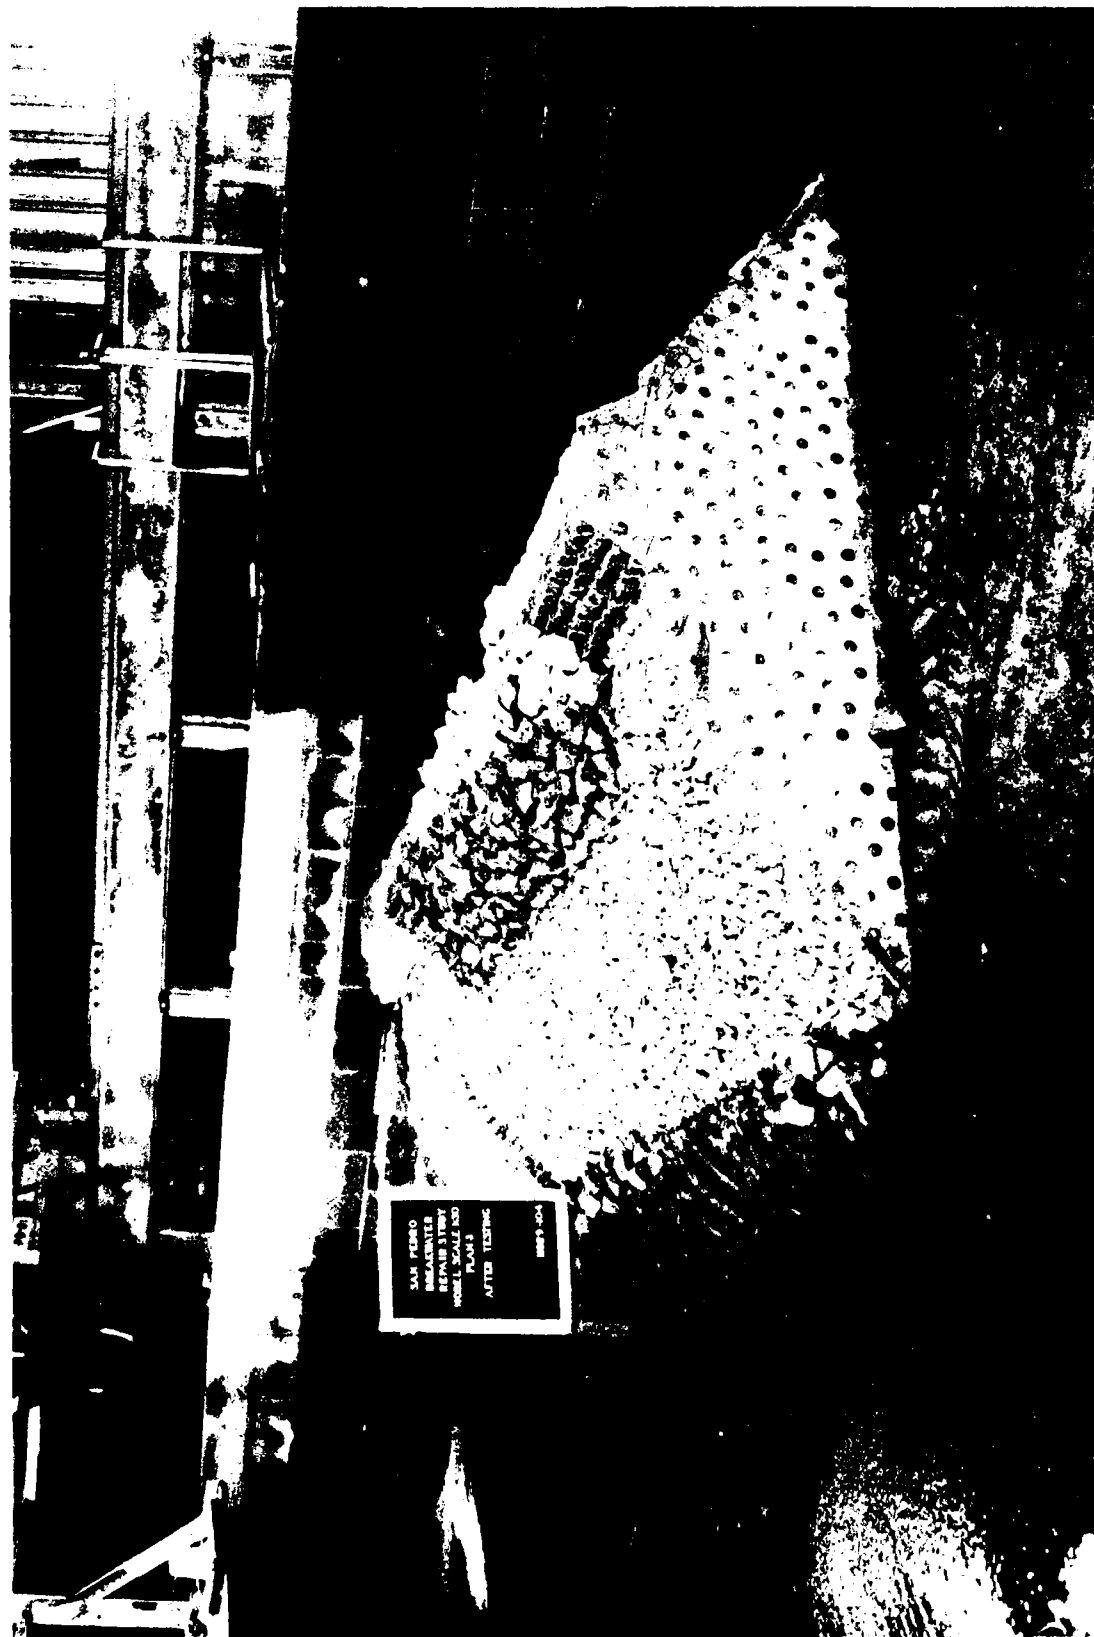
18. Plan 3 (Photos 19-22 and Plate 6) was selected for testing at wave direction 2 because it appeared to be the best alternative based on constructability and economic considerations. As requested by representatives of SPL, the granite block sections were wired in place so the stability of the repair section could be checked independent of the original structure. The test section was subjected to Hydrograph B. Wave attack at the 0-ft mllw caused slight movement as the stone shifted and then nested after construction. Testing at the +6 ft mllw caused minor damage to 13- to 20-ton stone at the seaward (left) transition and slight damage to 13- to 20-ton stone at the

shoreward (right) transition. There was also minor damage, caused by overtopping, of the 7- to 20-ton stone on the harbor side of the structure. Wave attack at the +8 ft swl caused moderate damage to the harbor-side 7- to 20-ton stone. Most of the waves overtopped the structure at this swl and there was minimum wave energy concentrated in the sea-side transition areas. There was slight change in the damage level as the hydrograph was run to completion. Based on these test results, it can be concluded that Plan 3 offers a more stable repair option for both wave directions 1 and 2 than the original breakwater. There was minor damage to the 13- to 20-ton stone at the seaward transition during testing from wave direction 2, but the structural integrity of this area remained intact. It appears that if there was a greater duration of long-period waves than tested at the +8 ft mllw level the 7- to 20-ton stone on the harbor side of the structure might be lost; however, the original granite block sections would fail before this happens.

Photo 21. Sea-side view of Plan 3 after subsection to Hydrograph B.
Angle of wave attack = 45 deg

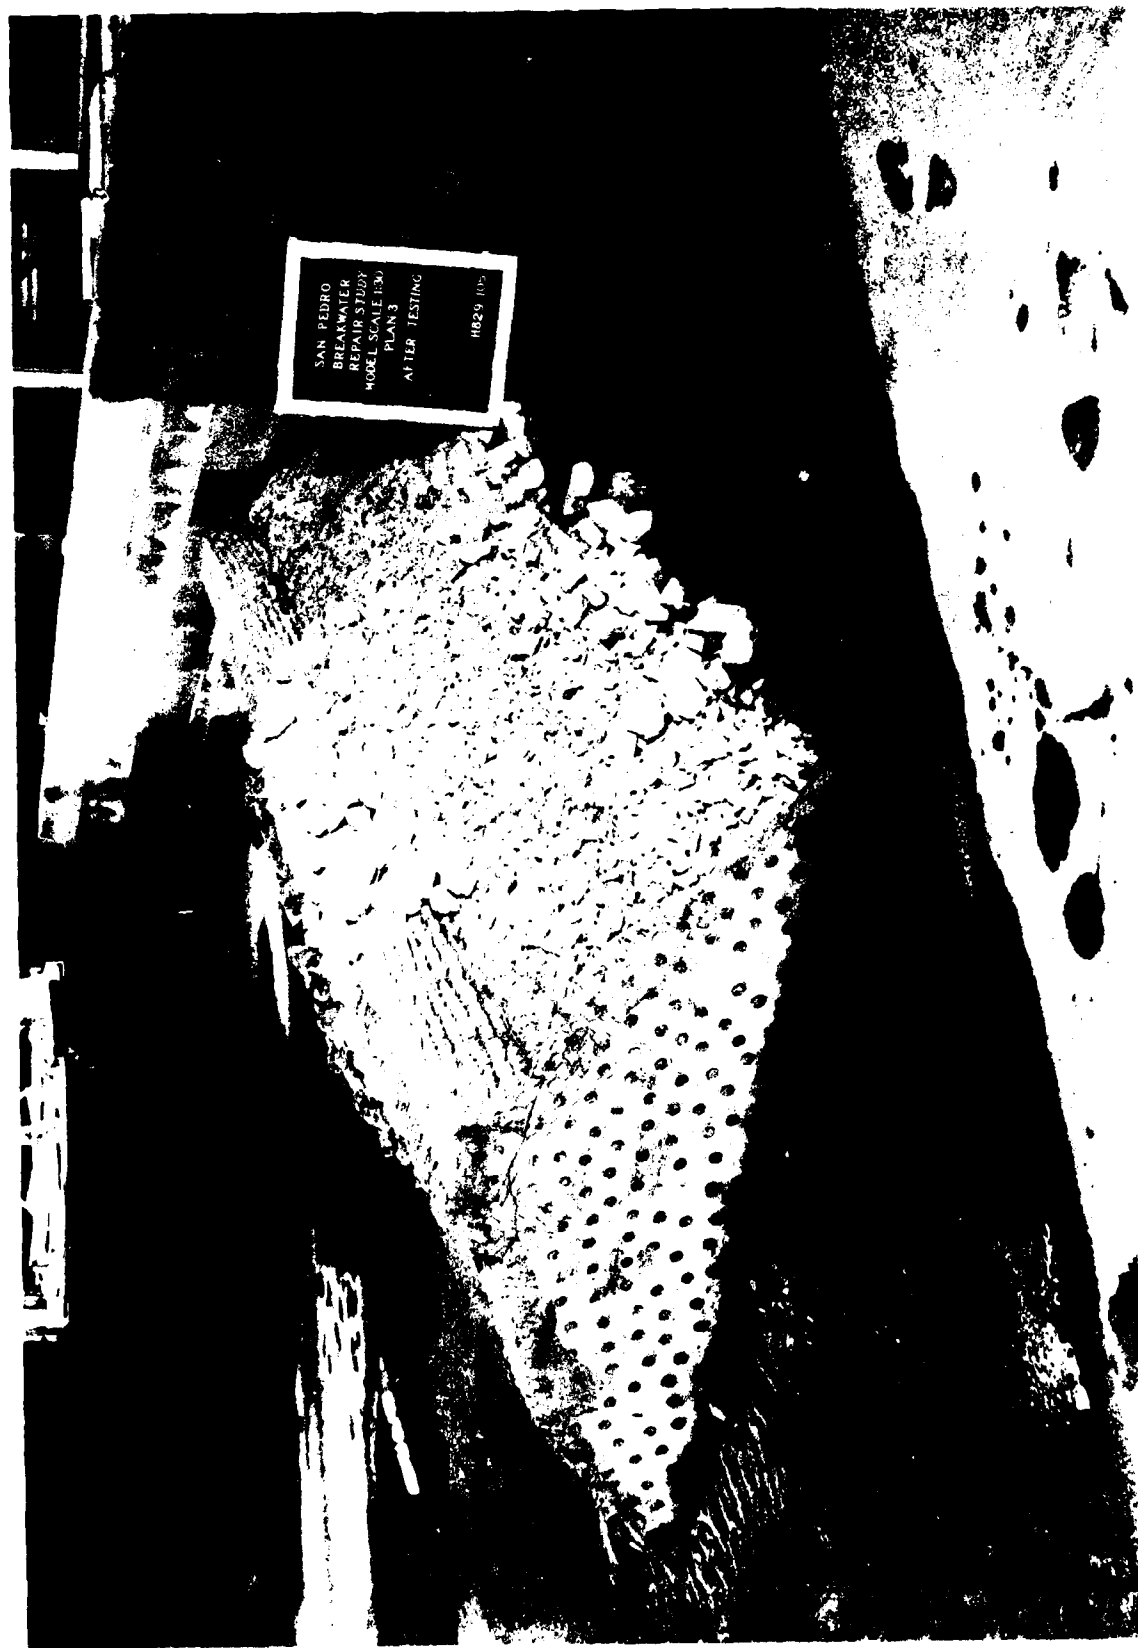
Photo 22. Harbor-side view of Plan 3 after subjecting to Hydrograph B.
Angle of wave attack = 45 deg
